FINAL
SITE INSPECTION PRIORITIZATION (SIP)
LETTER REPORT
IBM COUNTRY CLUB
DUTCHESS COUNTY, NEW YORK
CERCLIS NO.: NYD982531907

APRIL 1995

**IBM COUNTRY CLUB
SOUTH ROAD
TOWN OF POUGHKEEPSIE, DUTCHESS COUNTY, NEW YORK
CERCLIS NO. NYD982531907**

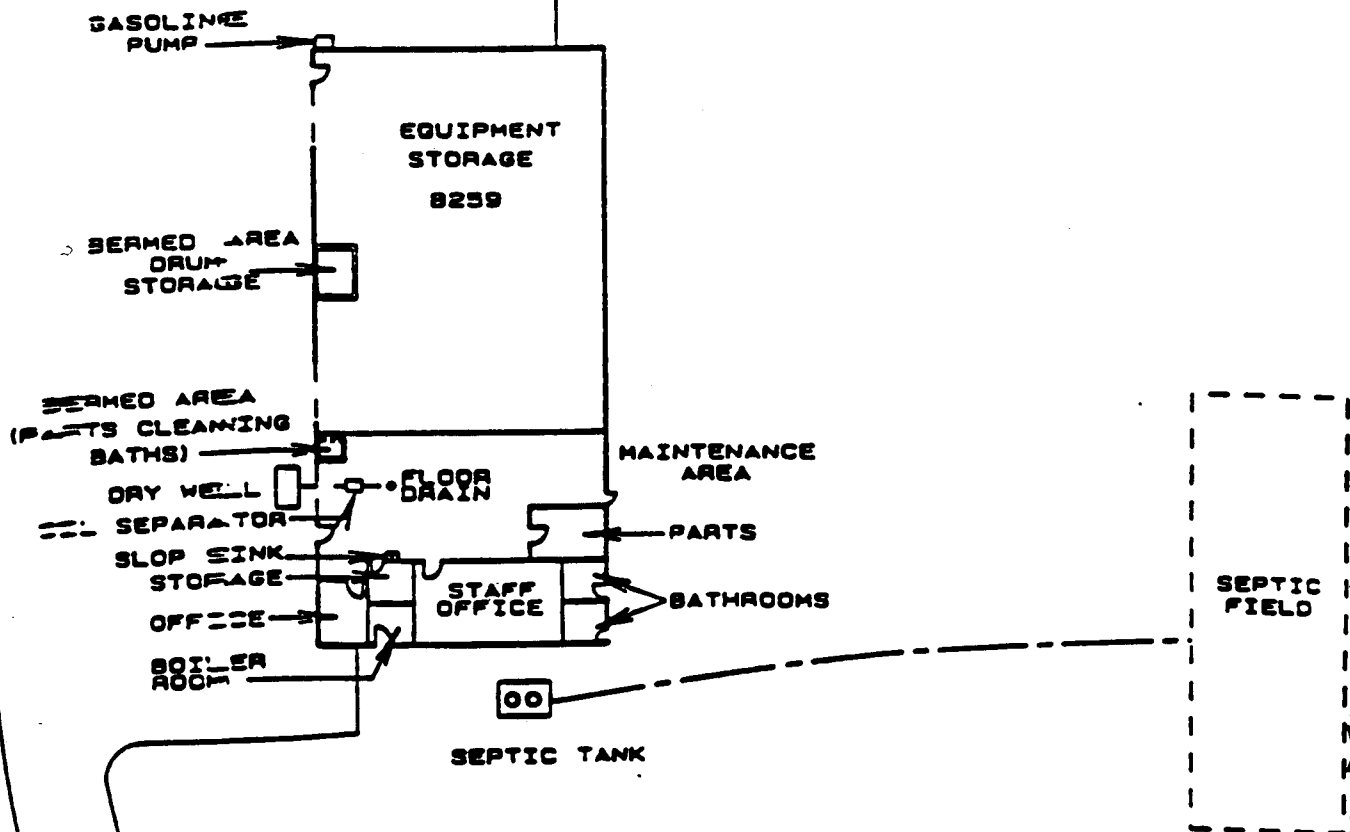
FIGURE 2
SITE B259 MAINTENANCE BLDG.
IBM COUNTRY CLUB
POUGHKEEPSIE, NY

B259 was used primarily to maintain golf carts and groundskeeping machinery. During a 1987 inspection by IBM, a floor drain was discovered which led to an oil/water separation tank and dry well. Solvents were used to clean the motorized equipment used to maintain the grounds. Degreasers were applied to the equipment, allowed to soak, and then rinsed off with water. The waste then exited the oil/water separator through a pipe and entered a dry well next to the building (Figure 2). IBM excavated the area surrounding the dry well and oil/water separator in 1988. During the excavation, soils and approximately 250 gallons of water were removed and sent to a RCRA-permitted facility (Ref. 4, p. 6 of 11; Ref. 9, pp. 1 through 6 of 6). Prior to backfilling, the oil/water separator was rinsed and the discharge pipe was plugged. The dry well was dismantled and standing water was sampled and sent to the laboratory for analysis. Analysis of the water samples collected from the well revealed the presence of 1,1,1-trichloroethane, acetone, tetrachloroethylene, toluene, and 1,1-dichloroethane (Ref. 4, p. 7 of 11).

A sink connected to an underground septic tank also was discovered in the maintenance building. The septic tank was found to discharge directly into a leach field approximately 2,900 square feet in area. The septic tank was sampled and concentrations of 1,1,1-trichloroethane and 1,1-dichloroethane were found (Ref. 4, p. 9 of 11). The contents of the septic tank were pumped and

the solid and liquid fractions disposed of at RCRA approved facilities. The septic tank was excavated and the discharge line to the leach field was plugged. The septic tank was replaced and the discarded tank sent to a secure landfill (Ref. 4, p. 9 of 11).
